Subject: **Edelweiss Dam (#D149004) Breach Analysis - Village District of Edelweiss, NH**

The purpose of this memorandum is to summarize the results of the Edelweiss Dam breach analysis. Wright-Pierce has conducted a breach analysis and developed an inundation map and is seeking review by the New Hampshire Department of Environmental Services (NHDES) Dam Bureau. Upon receipt of any comments, this memo and model will be finalized to support the development of the Emergency Action Plan (EAP).

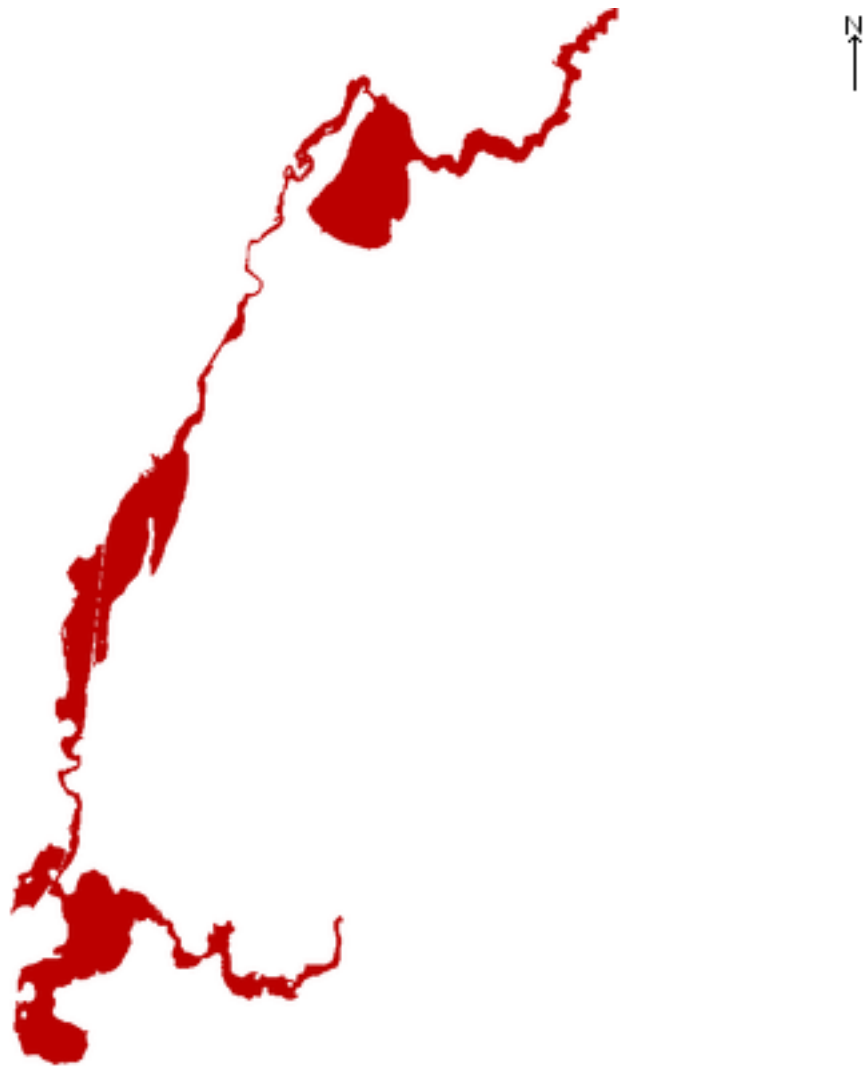
Figure 6. Coverage of DEM Raster Datasets in the Inundation Area.

Note: The DEM for this job was created from the source DEM raster datasets listed above. These DEM raster datasets were resampled and reprojected to the user defined cell size and UTM zone, respectively. Resampled and projected DEM raster datasets were then stacked in the order specific to the group under which this simulation was submitted.
